# TECHNICAL SERVICE BULLETIN

## Chatter/Shudder During Low Speed Turning Events

**26-2328**  
15 July 2026

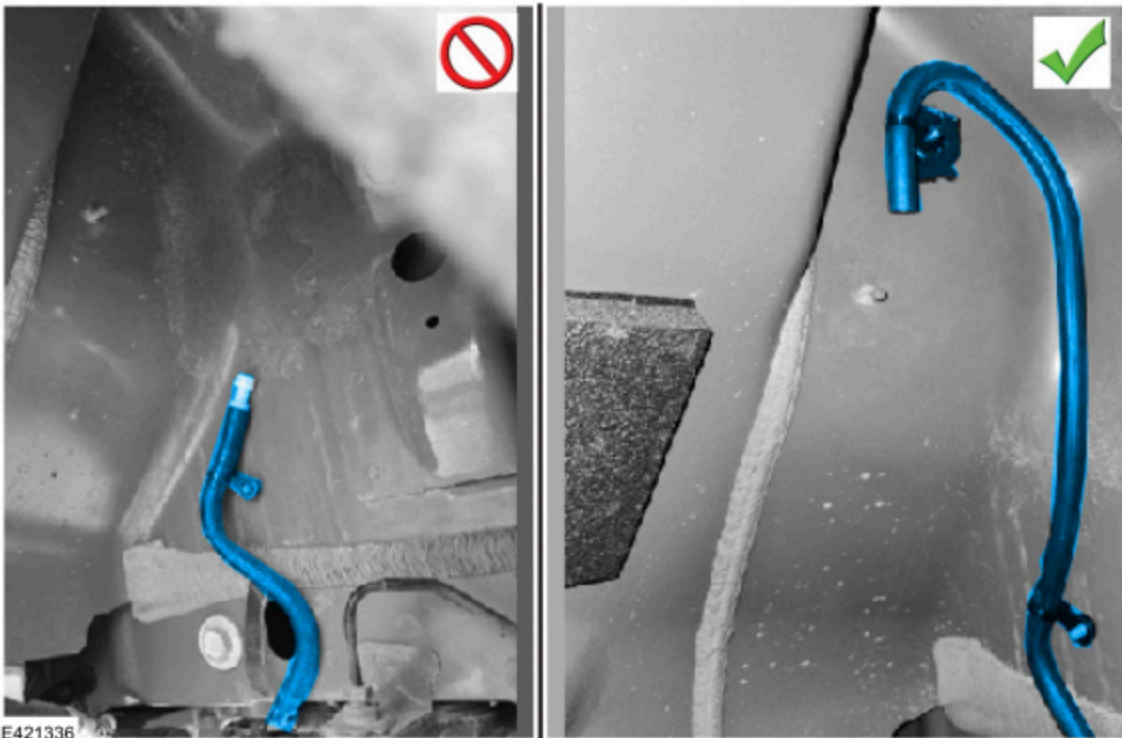
Figure 3

2. Inspect the RDU vent hose mounted behind the right rear fender splash shield. Is the vehicle equipped with the updated RDU vent hose as shown in the image with the green check mark in Figure 3?

- (1). Yes - this vent service procedure does not apply. Proceed to Step 29.
  - (2). No - proceed to Step 3.
3. Remove the right rear wheel. Refer to WSM, Section 204-04A.
4. Remove the retainers and screws from the right rear fender splash shield shown in Figures 4-6. Lower and fold the right rear fender splash shield in front of the brake caliper to access the RDU vent hose and upper section of the wheel well.

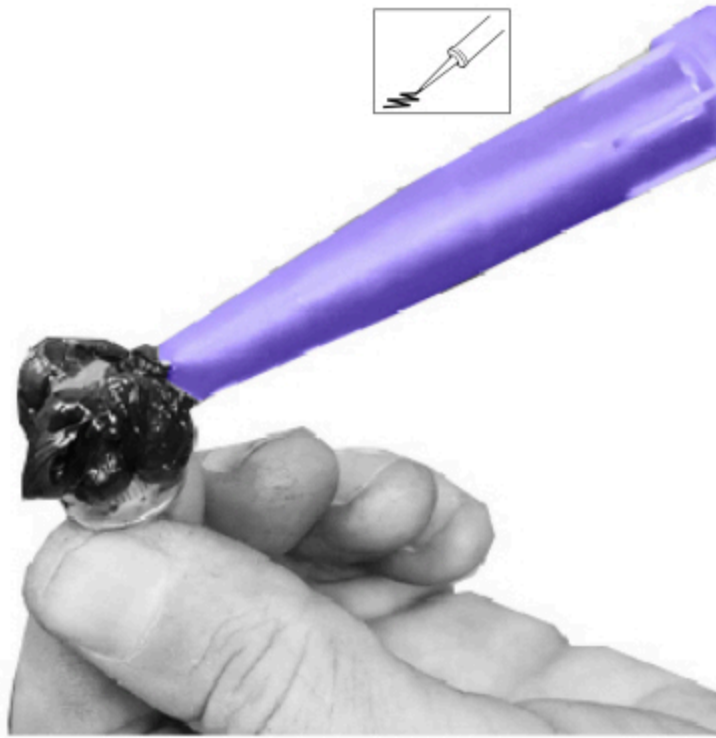
Figure 12

**CAUTION:** Failure to properly seal the stud rivet could lead to water entry into the passenger area.

22. Apply a generous amount of Motorcraft® Seam Sealer to the body side of the stud rivet. (Figure 12)
